MT. KEMBLE LAKE DAM

NJ 00363

PHASE 1 INSPECTION REPORT
NATIONAL DAM SAFETY PROGRAM.

Mt. Kemble Lake Dam. (NJ-00363).
Passaic River Basin. Primrose Brook-
Morris County, New Jersey. Phase 1
Inspection Report.

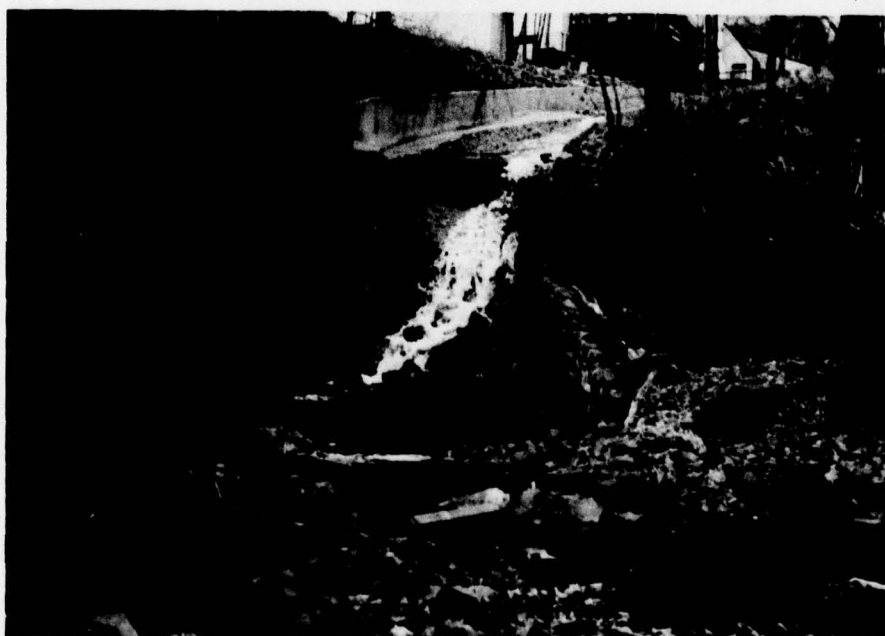
PHOTO 2

The stone masonry training wall along the east side of the lower section of the spillway discharge channel is in generally satisfactory condition. Water was observed flowing along the east side of the wall for a portion of its length. It could not be determined whether this flow is due to seepage through the dam or to leakage of discharge out of the spillway discharge channel.

SPILLWAY OUTLET

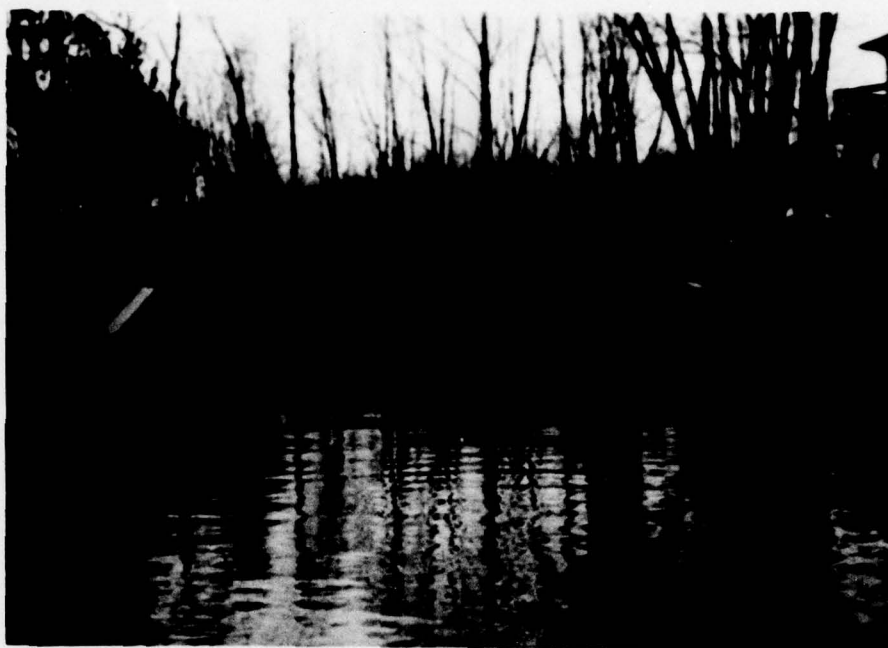
The concrete comprising the east and west training walls is in generally good condition. Three vertical cracks were observed near the point of intersection of the east training wall and the corewall. One crack was observed in each of the three branches of the intersection. These cracks could be indications of settlement of the training wall.

PHOTO 3
UPSTREAM VIEW OF SPILLWAY
